Manhole Inspection Summary

Manhole # S51M__013MH

Insp Date: **4/3/08 8:50 AM**

Location Address: **934 s. curley**

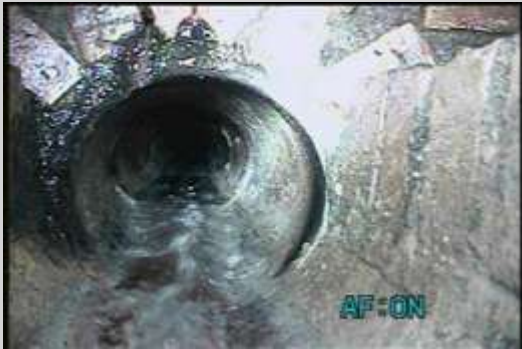
12 O'Clock Outflow

10 in. Circular Gravity Sewer
Pipe Out @ 12 O'Clock

Pipe Material: **Clay** ☐ Pipe Lined

Deposits: ☒ None ☐ Mud ☐ Sludge ☐ Debris ☐ Grease

Infiltration: **None** Pipe Seal Cond: **Unknown**

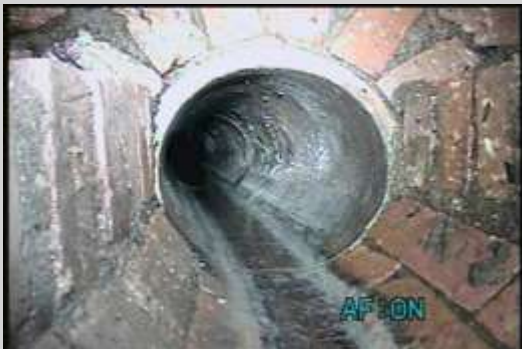
3 O'Clock Inflow

8 in. Circular Gravity Sewer
Pipe In @ 3 O'Clock

Pipe Material: **Clay** ☐ Pipe Lined

Infiltration: **None** Pipe Seal Cond: **Unknown**
